NAVWEPS REPORT 7630
NOTS TP 2635

EVALUATION OF PROPELLANT DEFECTS USING TRANSPARENT ROCKET MOTORS

Henry T. Sampson
Propulsion Development Department

U.S. NAVAL ORDNANCE TEST STATION

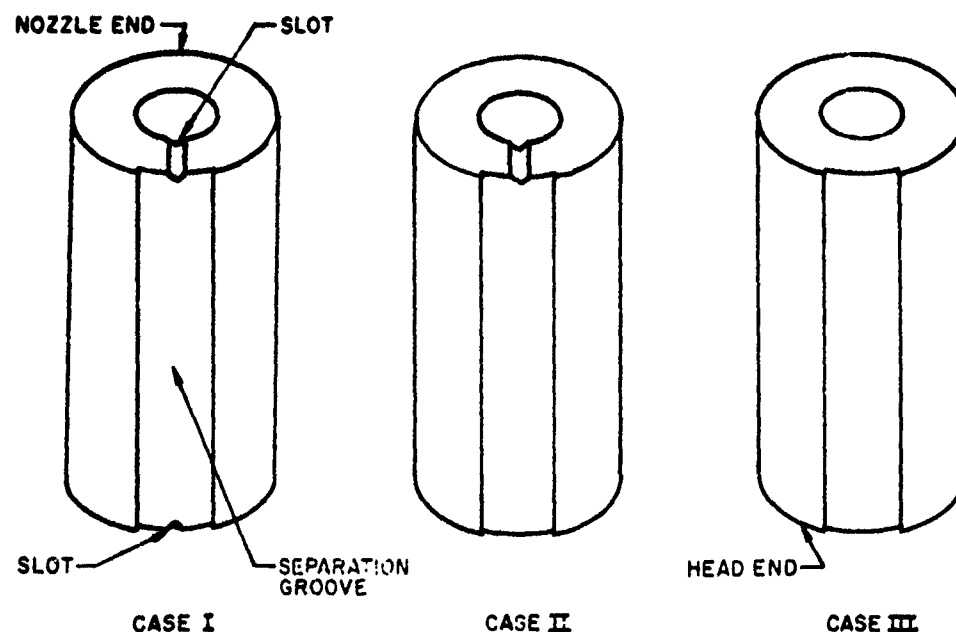
FIG. 2. Configuration of Motor Defects.

Certain defects were built into some motors by a modification of the fabrication method described above. Liner-propellant separation was achieved by placing a brass shim in contact with the liner surface before casting the propellant. The shims were coated with silicone rubber RTV 60 to promote easy removal from the motor. Shim thicknesses were varied according to the design of the experiment. After the propellant was cast and cured, the shim was removed leaving a portion of the propellant surface adjacent to the liner uninhibited and separated. V-shaped slots machined in some of the motors were positioned so that the uninhibited or separated area was connected by a channel, which permitted possible gas flow to this area from the main internal cavity of the motor. This configuration and its modifications are shown in Fig. 2 and are identified as Cases I, II, and III.

In relating these results with the configuration of the defect and the separation distance, it may be concluded that side burning occurs only when slots are provided on both ends of the grain. The slot on the head end of the grain provides a gas flow channel through which the combustion products flow and ignite the exposed propellant in the separation groove. The combustion products then flow across the fresh propellant surface and, by convective heat transfer, raise the temperature of the propellant until ignition occurs. The process repeats itself until the entire propellant surface in the separation groove is ignited. If a slot is provided on the nozzle end of the grain, the combustion products exhaust through the nozzle. If the main gas stream is connected by a flow channel with the propellant surface in the separation groove, side burning occurs. Side burning will not occur in Case II motors where only one slot is provided at the nozzle end, nor in Case III motors where no slots are provided.

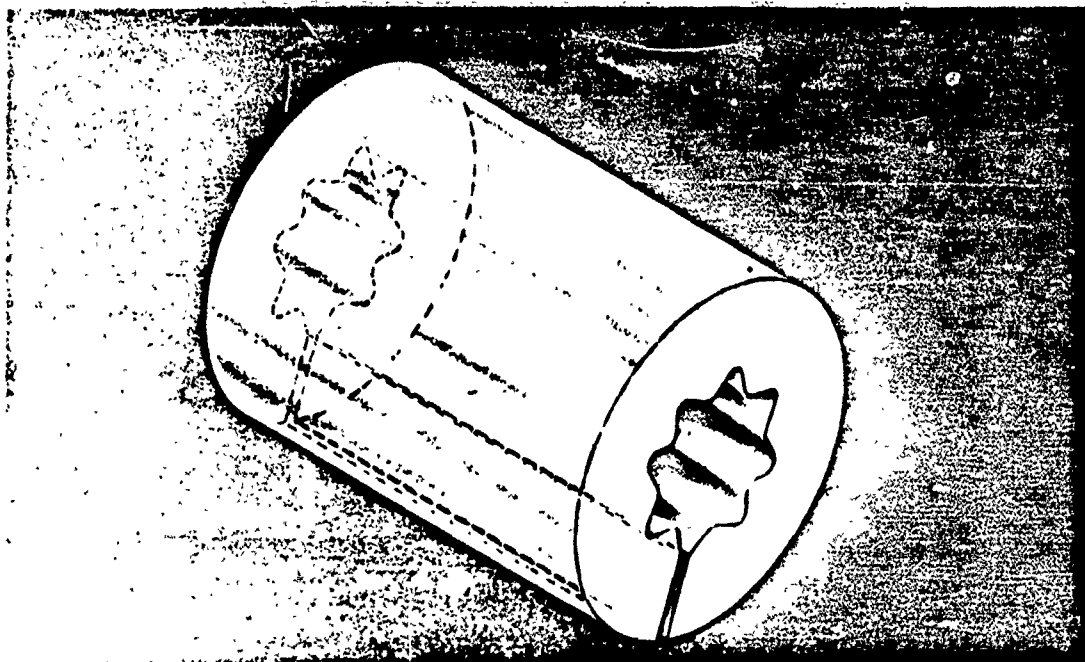
FIG. 3. Configuration of Cracked Grain.

The second motor defect fabricated (Fig. 3) was a simulated crack in the propellant grain. This was achieved by placing a silicone-coated

metal shim parallel with the mandrel so that it extended from the tip of a star point perpendicularly to the surface of the liner. This strip of metal was removed after curing of the propellant. The position of the crack was chosen to conform to the point of maximum stress in a normal grain under internal pressure. The grain would most probably crack at this position because of thermal stresses during severe temperature cycling. The shim thickness used was 0.010 inch, and the actual measured crack sizes varied between 0.010 and 0.014 inch.

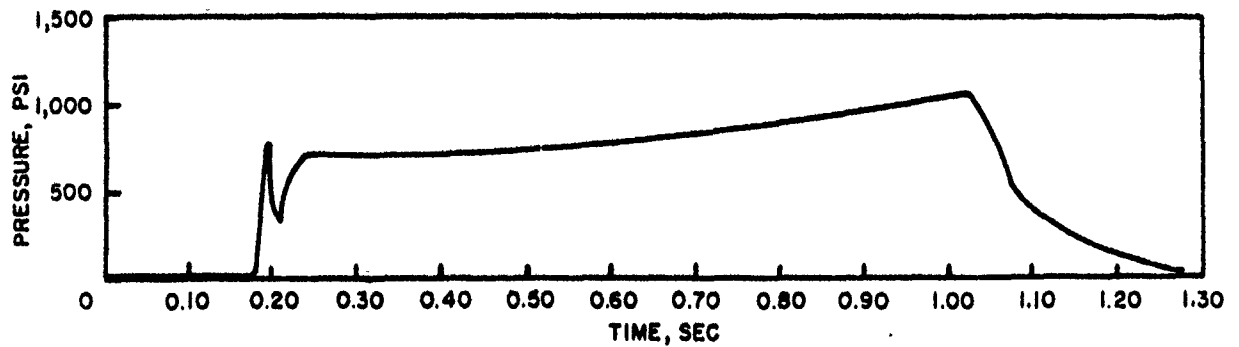
FIG. 7. Pressure-Time Curve, 2-Inch Control Motor No. 4.

The pressure-time curves are shown in Fig. 7 through 10. Figure 7 shows that the pressure-time history of the control motor is progressive. The internal configuration of the grain causes the burning-surface area to increase until web burnout. Test results are useful, however, since the curves for the abnormal cases were compared with that for the control round. Differences in total impulse of motors are caused by differences in propellant weight.

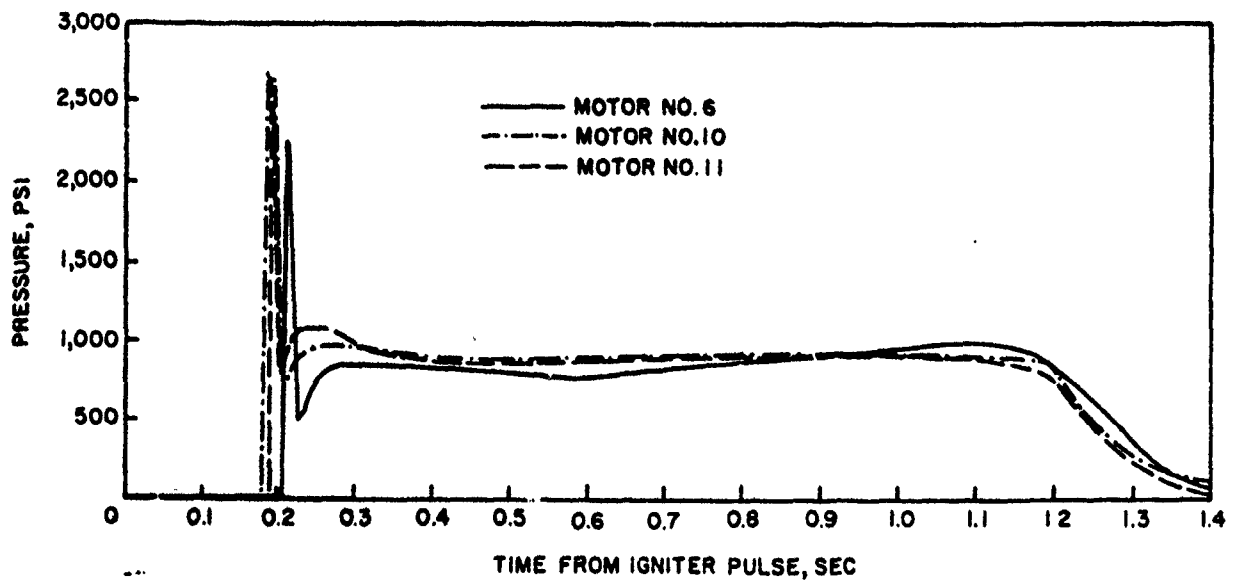
FIG. 14. Pressure-Time Curves, 2-Inch Motors No. 6, 10, and 11.

experiment and a summary of firing data. The corresponding pressure-time curves are shown in Fig. 13, 14, and 15. Motor No. 15 at 70°F and the control motor No. 9 at 120°F blew up. Photographic coverage was lost for these two motors, and, as a result, an explanation for their unexpected failure cannot be given. Extremely high initial-pressure peaks were obtained from all motors of this test series, including the control motors. Through a mistake in processing the propellant for these motors, coated ammonium perchlorate was used instead of the uncoated material. The higher pressure exponent of this material may have caused the high initial-pressure peaks.

These data indicate that the presence of a crack in the grain does not necessarily cause failure of the 2-inch motor. In fact, with the eight-point-star internal configuration, the presence of a crack changes the burning pattern of the grain from progressive to regressive. The progressivity ratio (ratio of burning surface at web burnout to initial burning surface area) changes from 1.28 without the crack to 0.73 with the crack. This effect is reflected in the pressure-time curves shown in Fig. 13. Because the propellant has a high temperature coefficient, the amount of progressivity or regressivity in the pressure-time curves is dependent upon the temperature of the grain before testing. This is seen by comparing the curves in Fig. 13 through 15. The pressure-time curves for the 120°F firings seem to be abnormal, having rather broad initial peaks. It cannot be determined, however, whether this is the result of temperature or of a crack in the grain, since the control motor fired at this temperature blew up.
